Test and Fault Analysis for High Power High Frequency HV Transformer

Wang Yanan, Xiao Dengming, Li Youhuai et al

Abstract: In order to analyze the causes for a high power high frequency HV transformer faults, a test platform is established; no-load test and wave recording are conducted for a faulty transformer and a faultless transformer. Features of test waveforms are summarized via current waveform comparison method. Based on the structure of power transformer, an equivalent circuit of the transformer considering stray parameters is put forward and a simplified circuit is come up with. The test result shows that it is distribution capacitance rather than air gap abnormality that causes high no-load current. Through the comparison of current waveforms, we can draw a conclusion that the fault is caused by the insulation breakdown of high voltage line package (layers or turns), which accords with the results through observation after the dismantlement of power transformer.

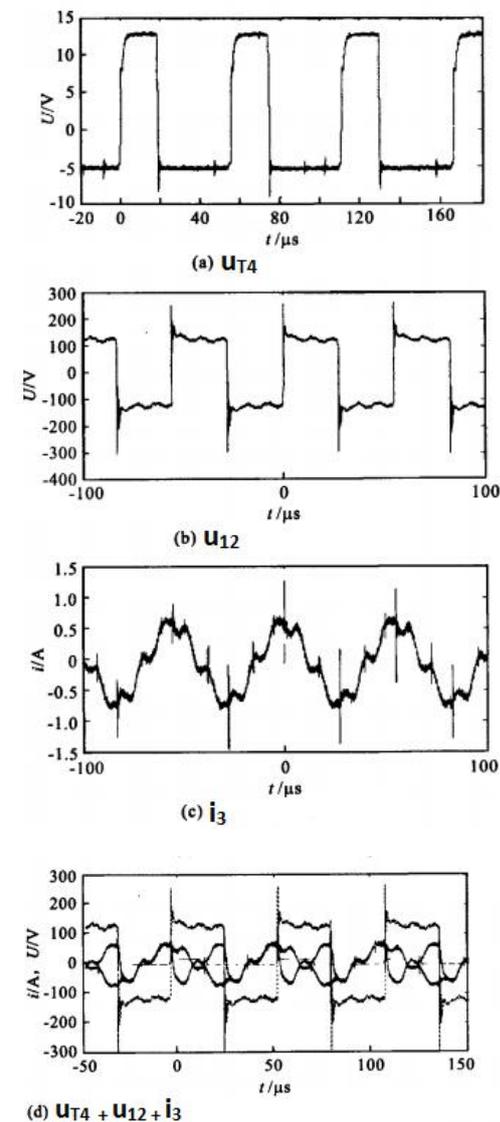
Fig.3 Waveforms of fault recording

When the three-phase input line voltage is 100V, U_{out} should be 15.758kV. However, output terminal voltage measured by voltage divider is 20.63-21.99kV. Some conclusions are made based on Fig.3:

1) The voltage ratio of DC output terminal is relatively high;

2) No-load input current of power transformer is high;

3) Current waveform phase is more than 90° than voltage;

4) The current waveform severely distorts and has abnormal peaks;

5) Average output power for one cycle of filter module is about zero.

Comparison of Fig.3 (c) and Fig.7 (c) indicates that the current waveform of faulty transformer distorts seriously and abnormal current peaks arise. Hence, the short circuit occurs owing to insulation breakdown for the transformer winding. There is no possibility that interturns of primary winding short-circuit or primary and secondary winding breakdown and short-circuit. It is believed that

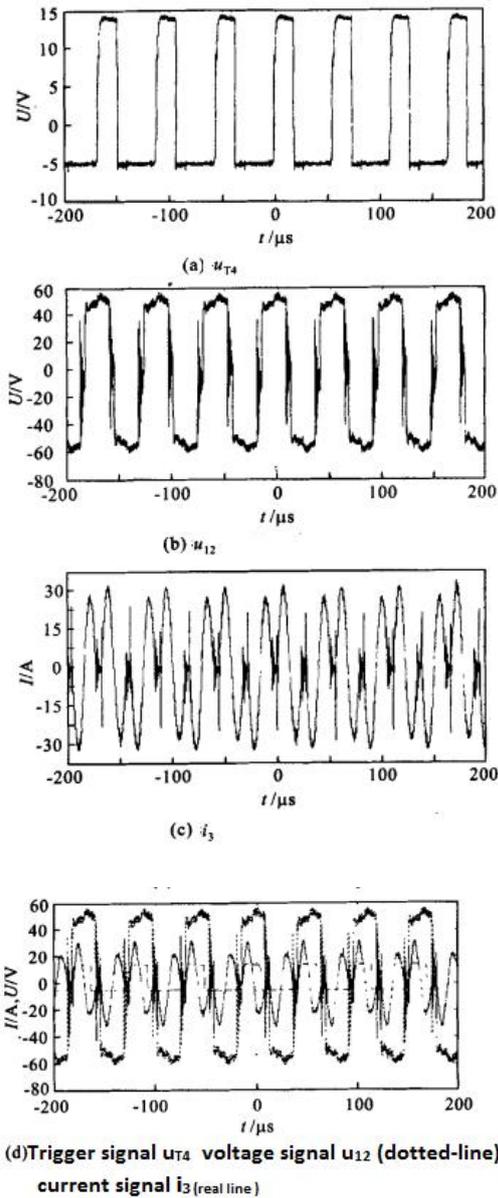
Fig.7 Waveforms of faultless transformer

As shown in the Fig.7 (c), the no-load input current of faultless transformer is still high, which is caused by distribution capacitance of transformer winding. As for power transformers with same structure and distribution capacitance, the capacitive reactance reduces according to frequency rate, leading to prominent problems such as high no-load current and heating inverter no-load. However, in terms of faulty transformer, the effect of short circuit causes no-load current to be higher, which is shown in Fig.3 (c). Many measures can be taken to eliminate the negative effect of distribution capacitance on the system. Generally speaking, they can be grouped into three categories: ① make use of distribution capacitance; ② make a supplement to distribution capacitance; ③ upgrade the structure of power transformer to reduce the distribution capacitance.

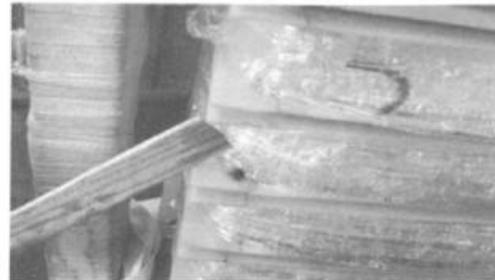
It is found that there indeed exists a phenomenon of insulation breakdown for secondary HV line package. For further details, see Fig.8. There are three faults in total.

(a) Insulation breakdown of HV line package-1

The cause is that there are small air bubbles between polyester films of breakdown points. Air bubbles lead to partial discharge, thus resulting in insulation breakdown. The high-class

vacuum oil process is recommended for polyester films or cable paper insulation for common vacuum oil process. In addition, the strength of HV output terminal should be paid more attention to.

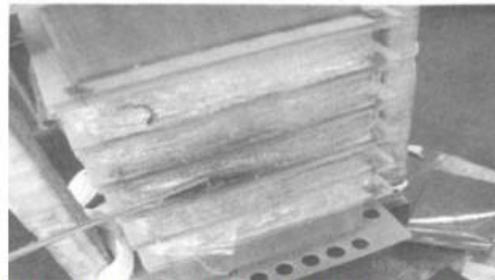
(b) Insulation breakdown of HV line package-2

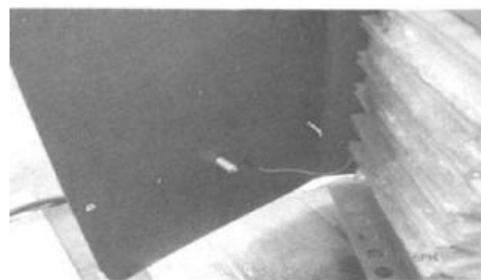
(c) Fault point of HV output terminal (Black)
