Test and Fault Analysis for High Power High Frequency HV Transformer

Wang Yanan, Xiao Dengming, Li Youhuai et al

Abstract: In order to analyze the causes for a high power high frequency HV transformer faults, a test platform is established; no-load test and wave recording are conducted for a faulty transformer and a faultless transformer. Features of test waveforms are summarized via current waveform comparison method. Based on the structure of power transformer, an equivalent circuit of the transformer considering stray parameters is put forward and a simplified circuit is come up with. The test result shows that it is distribution capacitance rather than air gap abnormality that causes high no-load current. Through the comparison of current waveforms, we can draw a conclusion that the fault is caused by the insulation breakdown of high voltage line package (layers or turns), which accords with the results through observation after the dismantlement of power transformer.

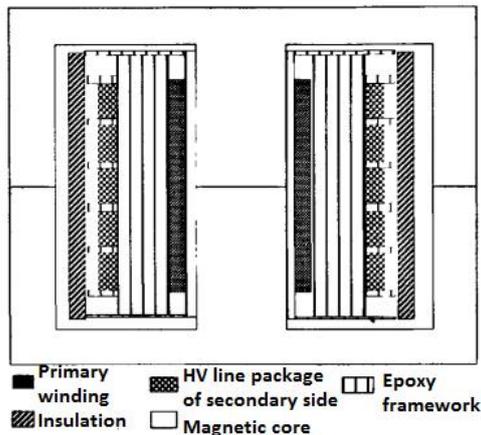
Fig.4 Structure of transformer insulation

shown in Fig.4. Details of insulation materials are as follows: the framework adopts epoxy board while polyester film for inter-layer insulation and inter-turn insulation; the insulation board is thick. The magnetic core is made of 8 U-shaped magnetic cores in parallel. The whole transformer core is immersed in the transformer oil.
